AN ANNUAL ASSESSMENT OF AQUATIC VEGETATION IN LITTLE PLATTE LAKE BENZIE COUNTY, MICHIGAN

JANUARY, 2020

Prepared by: Restorative Lake Sciences
18406 West Spring Lake Road
Spring Lake, Michigan 49456
www.restorativelakesciences.com
info@restorativelakesciences.com

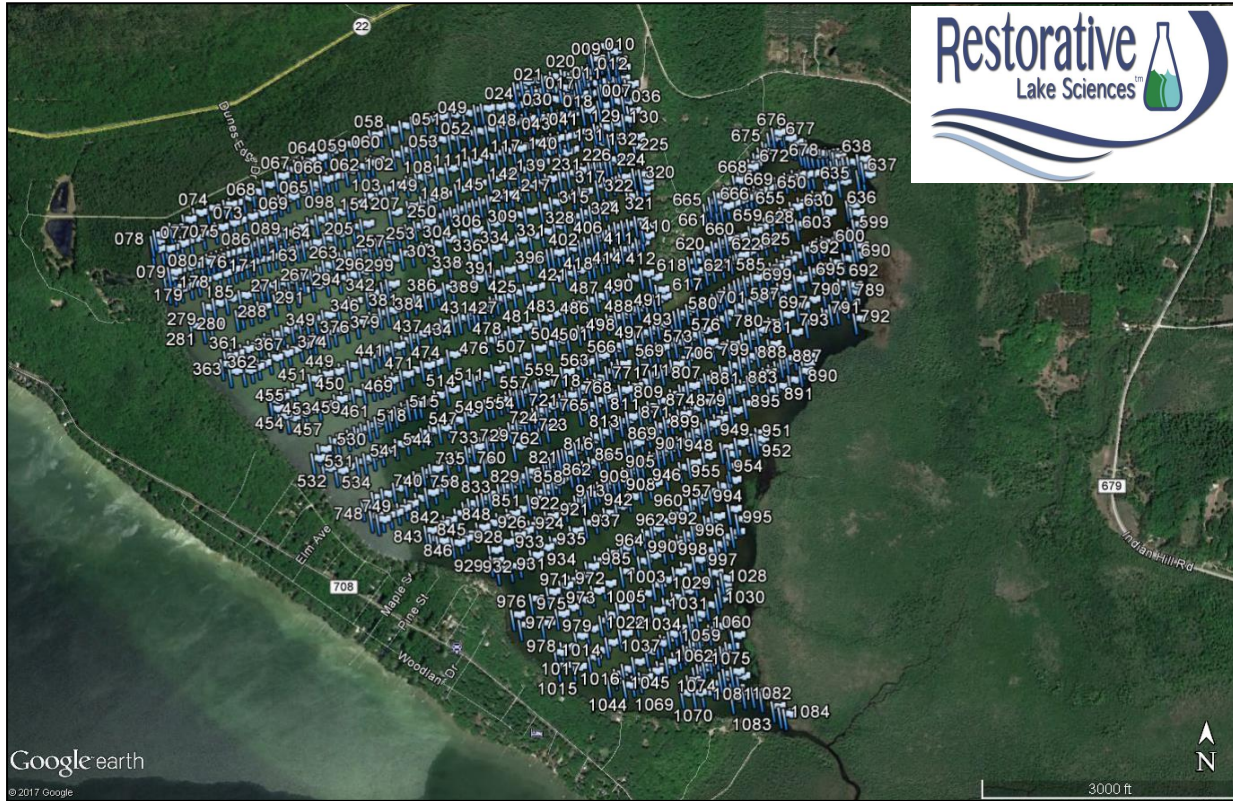
The GPS Point-Intercept method survey on June 20, 2019 consisted of 1,084 georeferenced grid points on Little Platte Lake, using a Lowrance HDS 9 GPS WAAS-enabled unit (accuracy within 6 inches). A combination of rake tosses and visual data accounted for each point and the distance between points for the survey. Earlier surveys utilized many more points at the initiation of the project.

Figure 2. Aquatic vegetation GPS sampling location points on Little Platte Lake, Benzie County, Michigan (RLS, 2019).

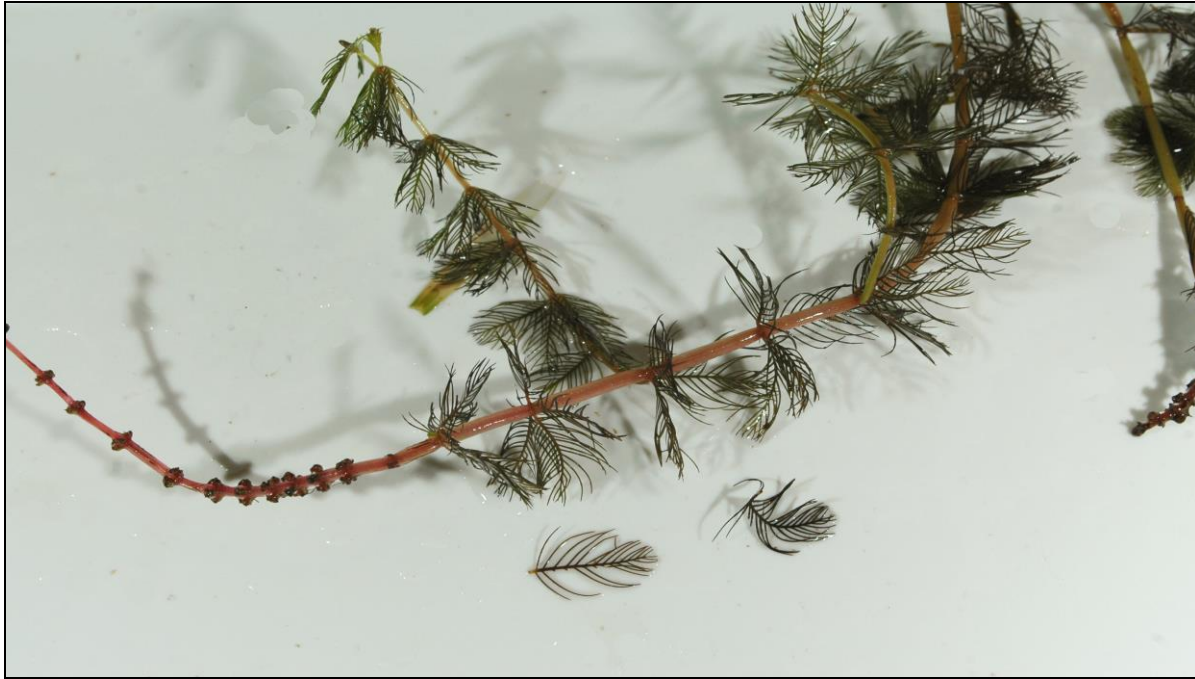
The June 20, 2019 survey found the presence of two invasive aquatic plant species which included the submersed exotic Eurasian Watermilfoil (*Myriophyllum spicatum*; Figure 3) and the emergent Phragmites (*Phragmites australis*; Figure 4). Exotic species found in Little Platte Lake during 2019 are listed below in Table 1. Figure 5 shows the distribution of EWM and Phragmites in and around the lake. NOTE: All EWM in the lake appeared to be dying as of the October 8, 2019 survey. Most of the previously treated Phragmites also showed signs of decay as they were treated in late-September 2019.

Figure 3. Eurasian Watermilfoil with seed head and lateral branches. © RLS

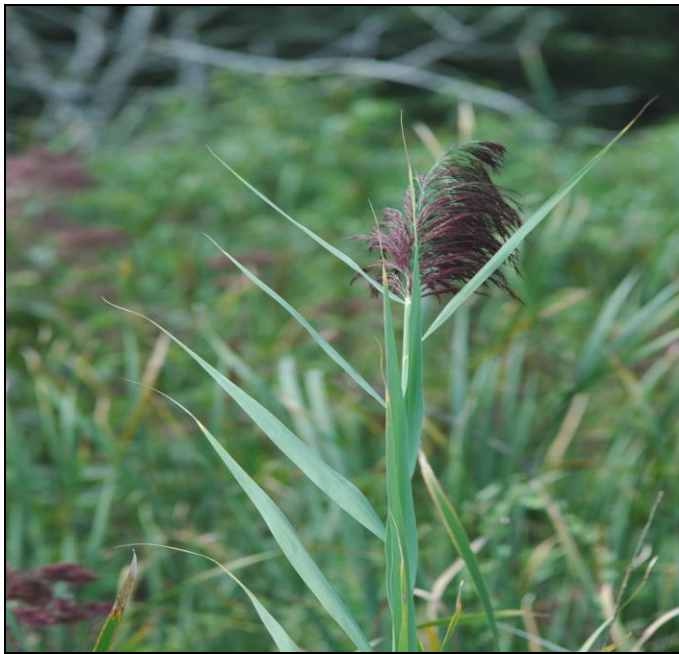
3. There were approximately 2.5 acres of invasive Phragmites around the lake which were found in wetland areas surrounding the lake. This emergent invasive displaces native emergent aquatic plants and over time can form a monoculture. However, the October 8, 2019 survey determined that although the Phragmites were still present, the late-September treatments from the CISMA were effective and the plants showed signs of senescence and damage.

Figure 4. Phragmites. © RLS

Invasive emergent Phragmites were treated by the local CISMA in late September 2019 with great success and this will be evaluated again in 2020.

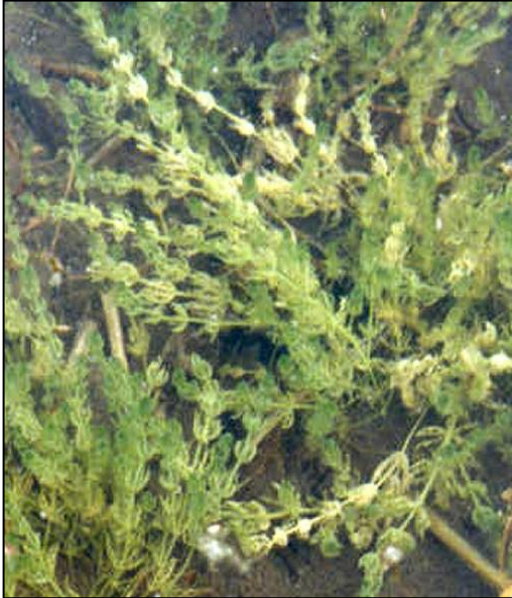
The most common native aquatic plant species include the submersed macro alga, Chara which carpets many areas on the lake bottom. This plant has a skunky odor and a brittle feel. It serves as favorable fish spawning habitat. The second and third most common species include Southern Naiad and Illinois Pondweed. Both of these species are excellent fish cover and rarely cause problems with aquatic vegetation balance.

Figure 6. A photograph of Chara (*Chara vulgaris*)
