AN ANNUAL ASSESSMENT OF AQUATIC VEGETATION IN LITTLE PLATTE LAKE BENZIE COUNTY, MICHIGAN

December, 2021

Prepared for: Little Platte Lake Association
C/O: Mr. Jerry Rupley

Prepared by: Restorative Lake Sciences
18406 West Spring Lake Road
Spring Lake, Michigan 49456
www.restorativelakesciences.com

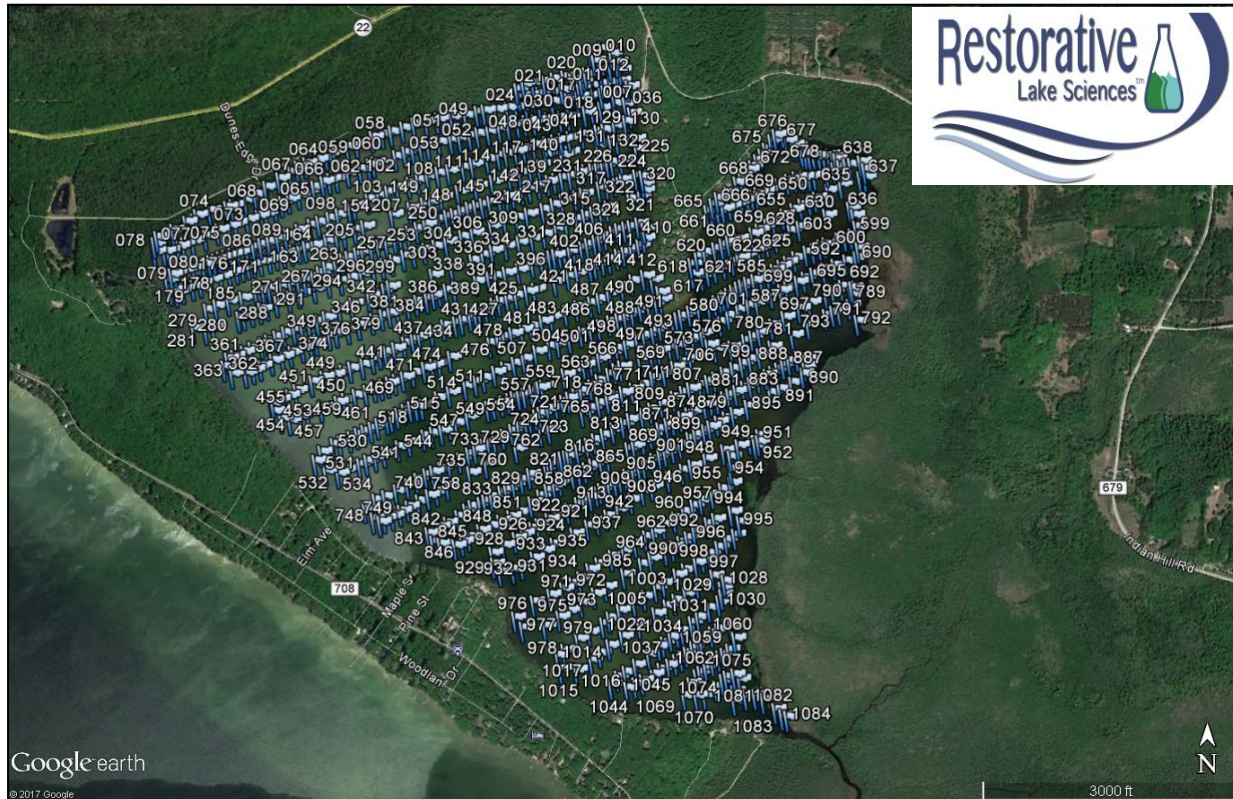
The GPS Point-Intercept method survey on June 22, 2021 consisted of 1,084 geo-referenced grid points on Little Platte Lake, using a Lowrance HDS 9 GPS WAAS-enabled unit (accuracy within 6 inches). A combination of rake tosses and visual data accounted for each point and the distance between points for the survey. Earlier surveys utilized many more points at the initiation of the project.

Figure 2. Aquatic vegetation GPS sampling location points on Little Platte Lake, Benzie County, Michigan (RLS, 2021).

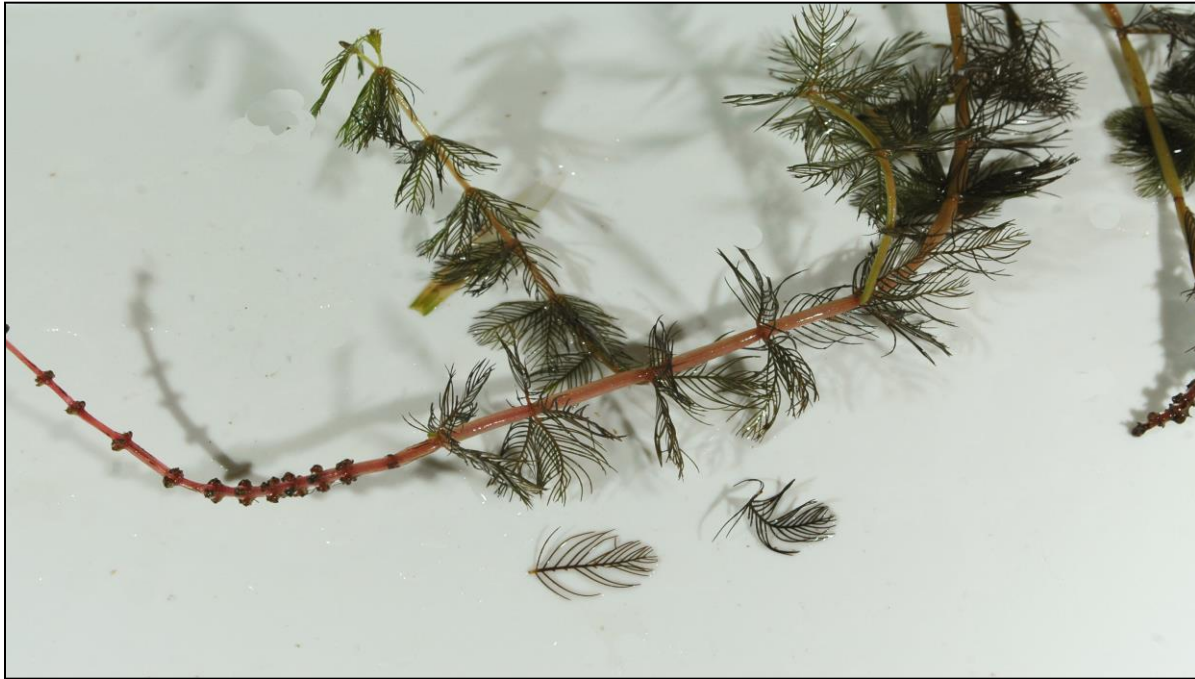
The June 22, 2021 survey found the presence of two invasive aquatic plant species which included the submersed exotic Eurasian Watermilfoil (*Myriophyllum spicatum*; Figure 3) and the emergent Phragmites (*Phragmites australis*; Figure 4). Exotic species found in Little Platte Lake during 2021 are listed below in Table 1. Figures 5a-b show the distribution of EWM and Phragmites in and around the lake. NOTE: All EWM in the lake appeared to be absent except for one small area near the access site where manual removal was recommended for 2021. Most of the previously treated Phragmites also showed signs of decay as they were treated in late-September 2019. However, some green stolons of new growth were noted in the treatment area and thus another treatment may be needed in 2022.

Figure 3. Eurasian Watermilfoil with seed head and lateral branches. © RLS

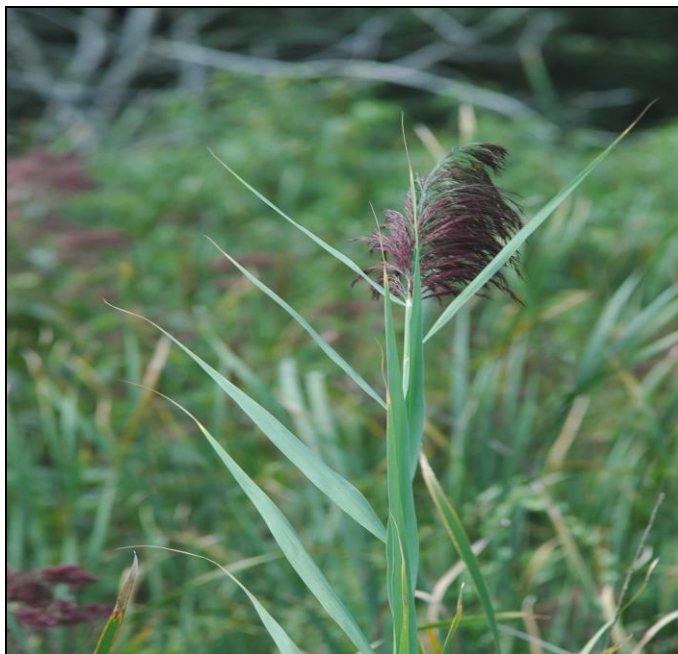
Figure 4. Phragmites. © RLS
